NEAL DAM  
WASHINGTON COUNTY, COMMONWEALTH OF PENNSYLVANIA  
NDI No. PA 00494  
PennDER No. 63-68

⑥ PHASE I INSPECTION REPORT  
NATIONAL DAM INSPECTION PROGRAM.

Neal Dam, Washington County, Pennsylvania  
NDI No. PA 00494, PennDER No. 63-68  
Tributary of Chartiers Creek  
Inspected 6 December 1979

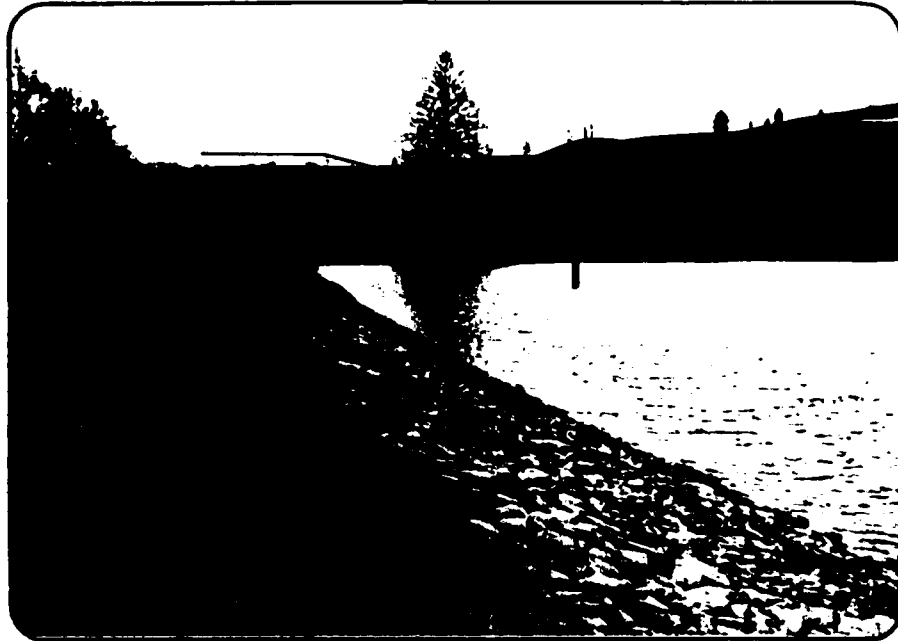
**PHOTO 5. View of the Riprap and Crest of the Embankment  
from the Left Abutment**
